PRODUCT UPDATE

March 2021

AIC Version 8.5 Software Update Available

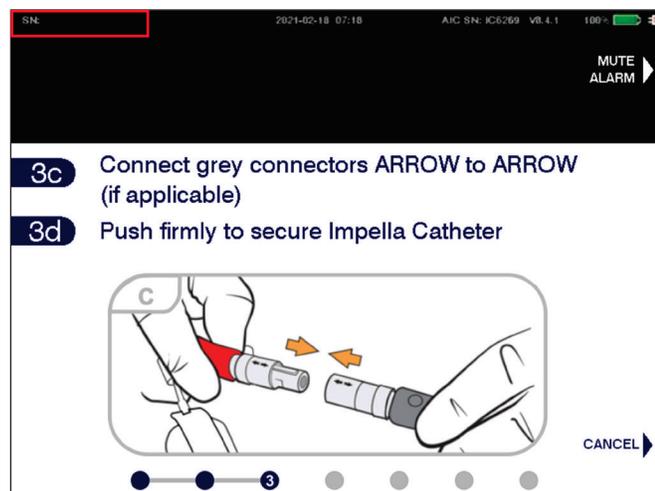
During Case Start, if the pump is connected to the AIC but the Impella pump type and serial number are not displayed (shown in red) and the AIC continues to instruct a user to connect the pump, then this is likely an issue with the console recognizing the pump. This is a rare occurrence, however if it does happen this is not an issue with the pump itself, rather the AIC software.

AIC Screen if Pump is Not Recognized

1. Disconnect the pump
2. Reboot the AIC
3. Reconnect the pump and push firmly to ensure complete connection, continue Case Start
4. If the pump is still not recognized, switch to backup controller*
5. If a backup controller is not available, call Field Service to discuss getting a loaner sent

A fix for this issue has been released in version 8.5 software. This software will begin to be distributed through preventative maintenance and for new AIC consoles. It is recommended that all consoles are upgraded to this version of software as soon as possible.
